RETAINING WALL COLLAPSES

A large five-metre retaining wall collapsed after recent rain, sending tonnes of steel and concrete crashing down a steep building site in Woronora.

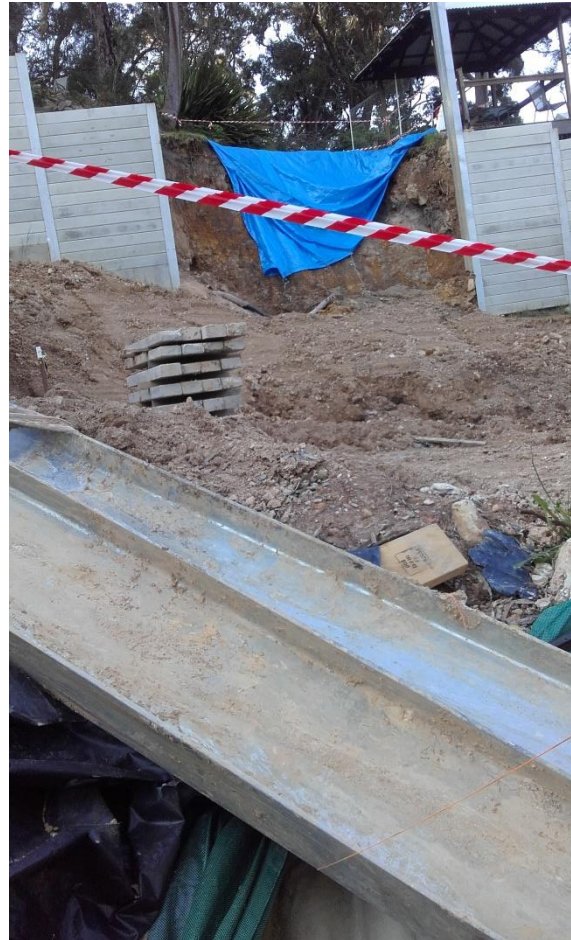
Two huge girders topped with three panels of loose slabs last week (photo). They were scattered like giant dominos, as the shallow soil supporting them was washed away, including part of a neighbour's yard.

There was no sign of concrete foundations for the girders, only steel buried in local clay on rock.

About 20 percent of the new wall has collapsed, despite approval by private engineers whose advertising sign has disappeared from the fence.

The design of foundations is unknown, after longer girders were quickly dug in by workmen on weekend overtime, with a short length of ag-pipe buried to channel runoff – toward the panels further downhill.
